REAL ESTATE INSPECTION REPORT

Ana Politkovskaya 4g - 212, Saburtalo, Tbilisi

Date: 11.05.2022	Time: 13:00-14:15	Report ID: Sample report
Property: Ana Politkovskaya 4g Saburtalo, Tbilisi	Client:	Inspector: Aleksandre Chkhobadze

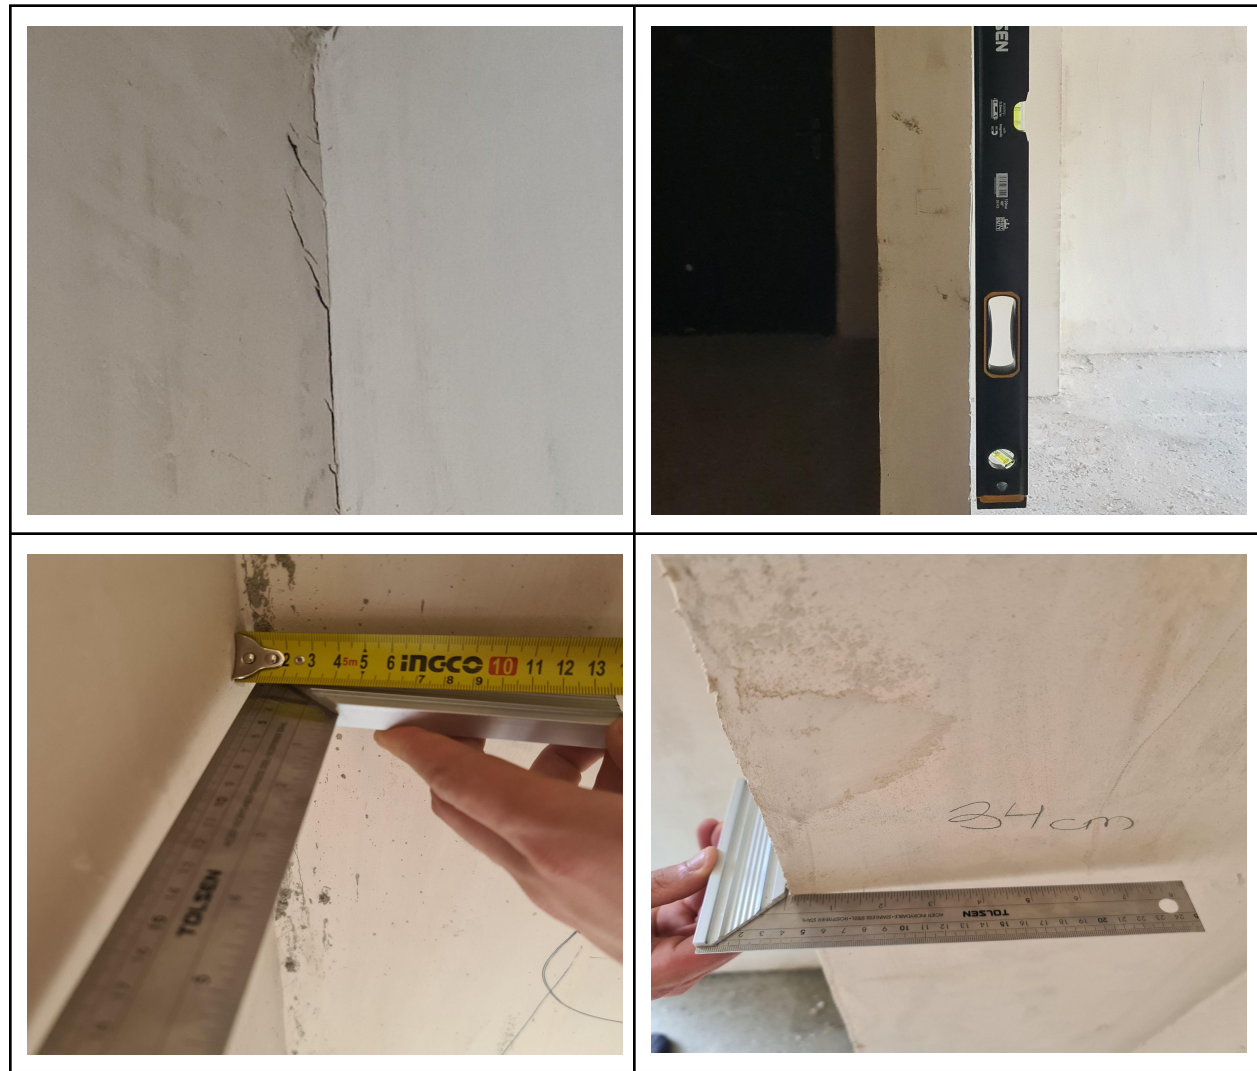
1.2 INTERNAL WALLS

The plastering is done unprofessionally, as the surface of the walls are uneven in some places. Also, there are places where the used gypsum-clay mixture is damaged and needs to be removed. Corners are not 90 degrees in most cases.

In order to fix all the above-mentioned defects, there are three possibilities:

- Remove the gypsum-clay mixture and place it from the beginning to have straight walls and get 90 degree corners.
- Use gypsum boards on the walls to make the walls even and bring out the 90-degree corners.

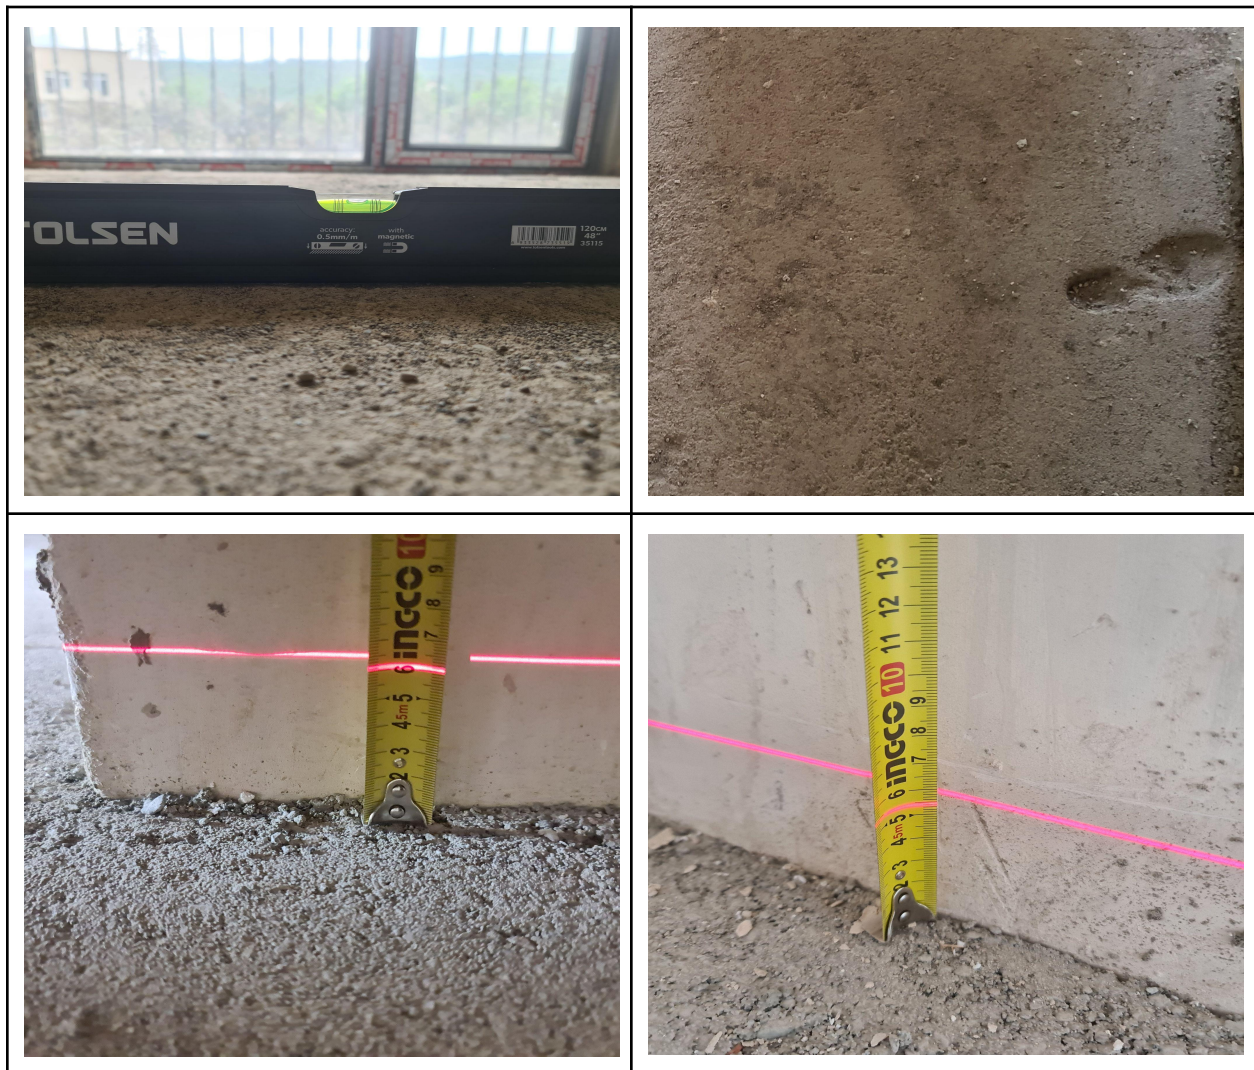
1.3 FLOORS

The screed on the floors is uneven, with a deviation of 1 cm from one corner to the other. In the middle the floor surface is even.

Screed should be smoothed and straightened after the heating and water pipes are installed. It is recommended to use a self-leveling screed, as it will smooth the floor in mm accuracy. If the surface is not even, the covering (laminare, parquet) will move or squeak, and in worst cases, will get damaged.

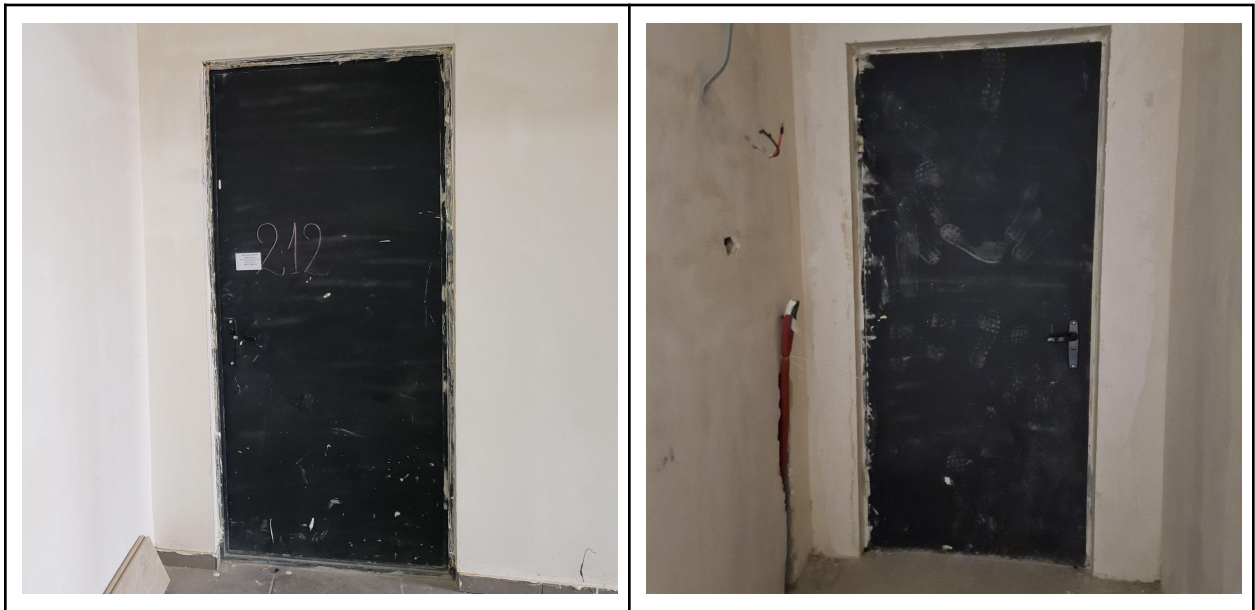
1.4 CENTRAL DOOR

No defects were detected at the time of inspection.

- Peephole should be installed before plastering and painting the door.
- Surface of the door should be plastered, smoothed, primed, and finally painted.
- It is highly recommended to replace the door lock, as it has been used by construction workers.

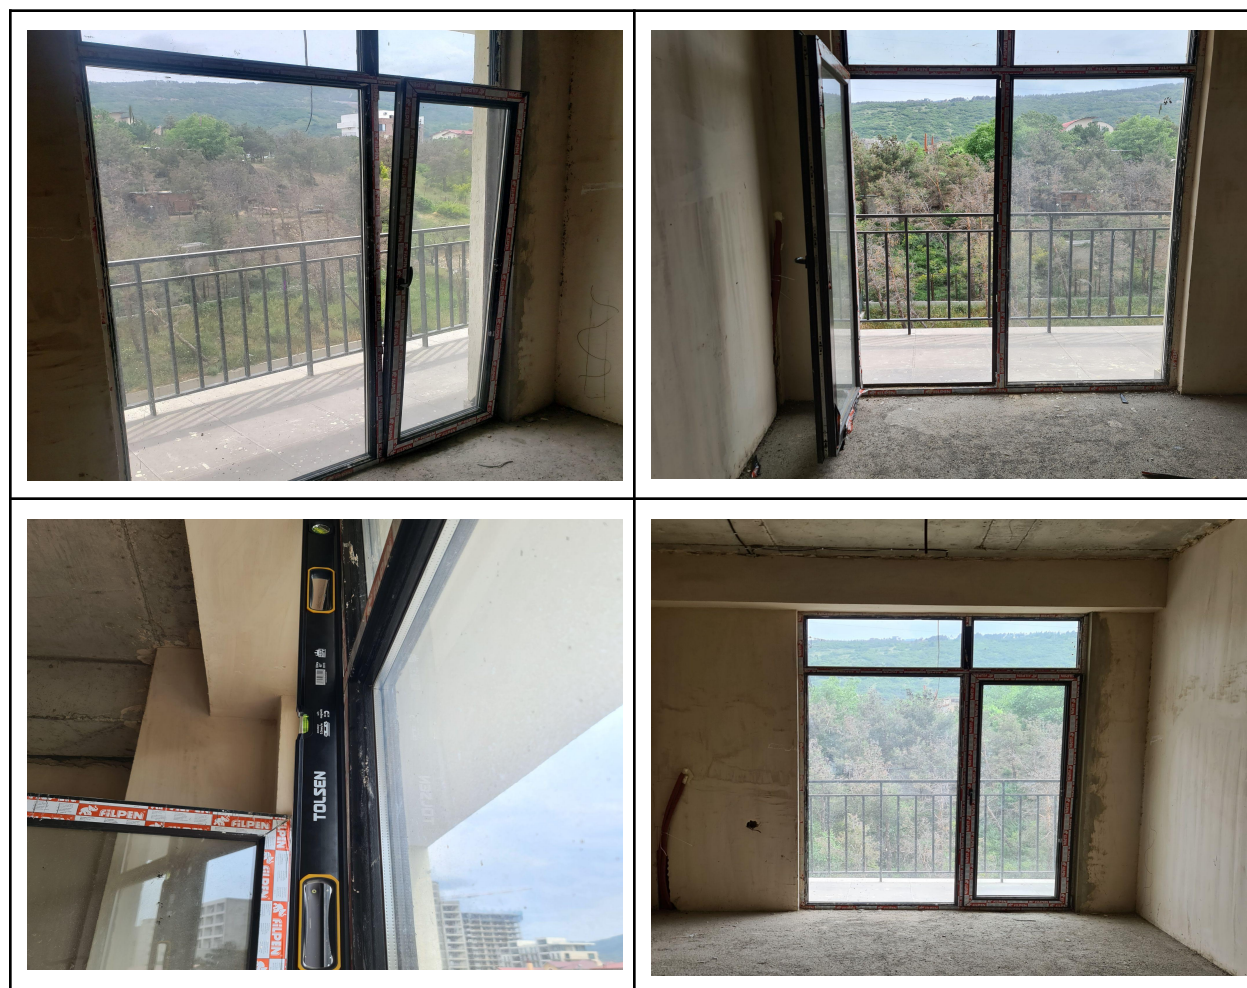
1.5 PVC WINDOWS AND DOORS

One of the balcony doors (middle room) does not close properly. The door is also missing one mechanism. The window frame is deformed.

- As the building is not finished yet, a construction company should get the doors regulated and fixed.
- The deformed frame should be replaced, or the wall should be chased and the window should be placed in the right position.
- Before the renovation, the windows should be covered, so they will not get damaged by plastering and paint works.
- The lower balcony door rails should be cleaned of cement and other materials, as it will not allow the doors to be closed properly, which can lead to door deformation.

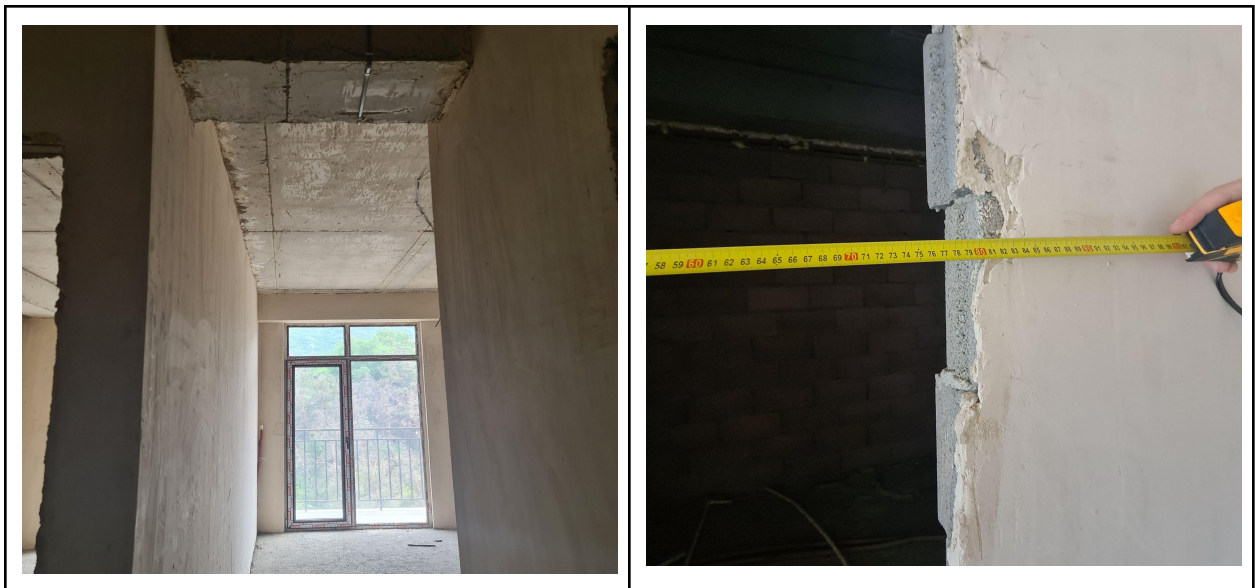
1.6 ROOM DOORS

One bedroom does not have the right measure hole for the door, and it looks like it has been left unfinished.

There should be gypsum used to make the upper part for the door hole. This can be done before the plastering is done throughout the apartment.

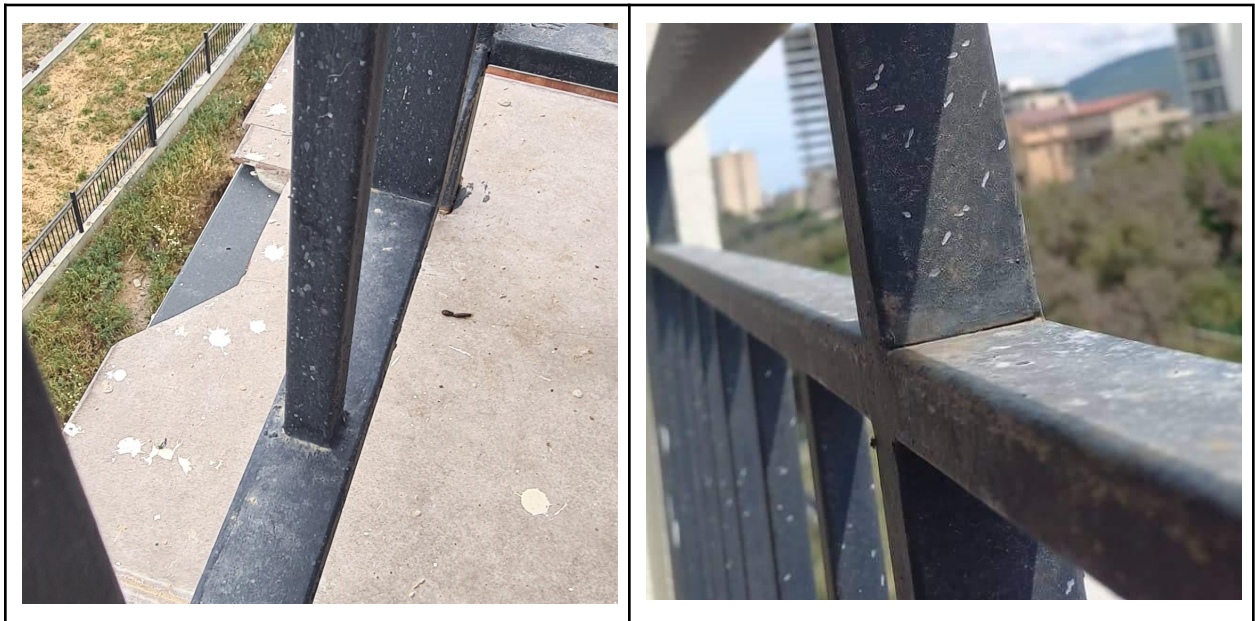
1.7 BALCONY/TERRACE

One of the ceramic tiles is broken. The railing has corrosion in some places.

- The broken ceramic tile should be replaced.
- Metal railings should be cleaned, primed, and painted.

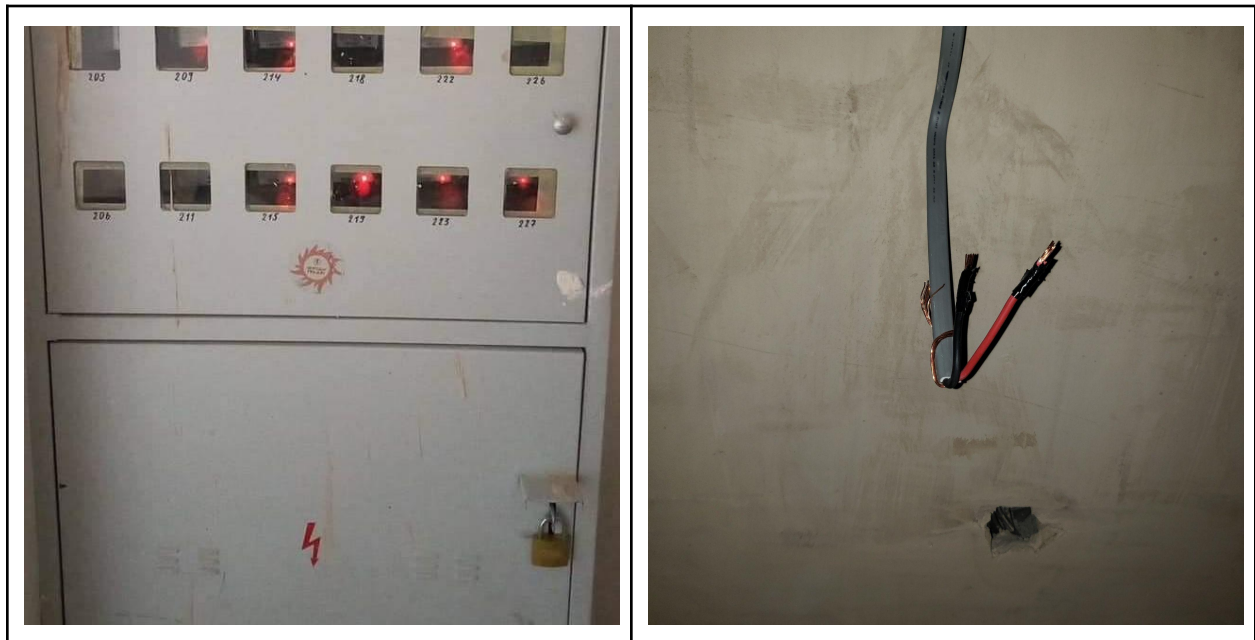
2.1 ELECTRICITY

Cables could not be tested as the electrical meter cabin was locked, so the electricity was not possible to be switched on.

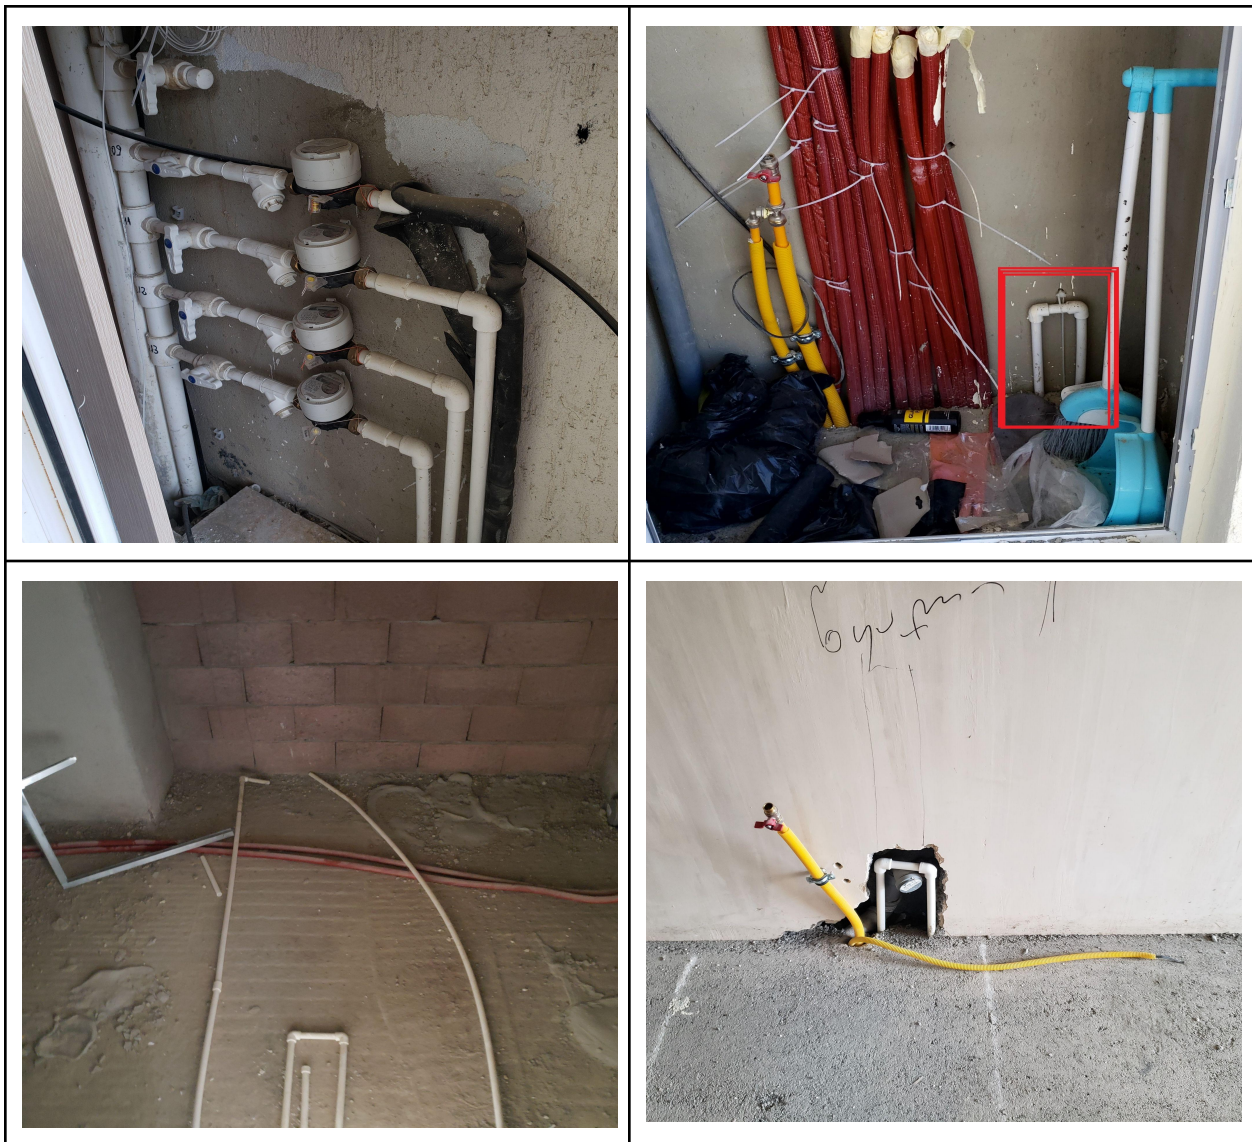
2.2 WATER SYSTEM & PIPES

At the moment the kitchen and bathroom are both connected to the same system, which means that if water is used in one room, at the same time the water pressure will go down in the other room.

To fix this problem, there should be cold and hot water pipes installed separately in the bathroom and kitchen.

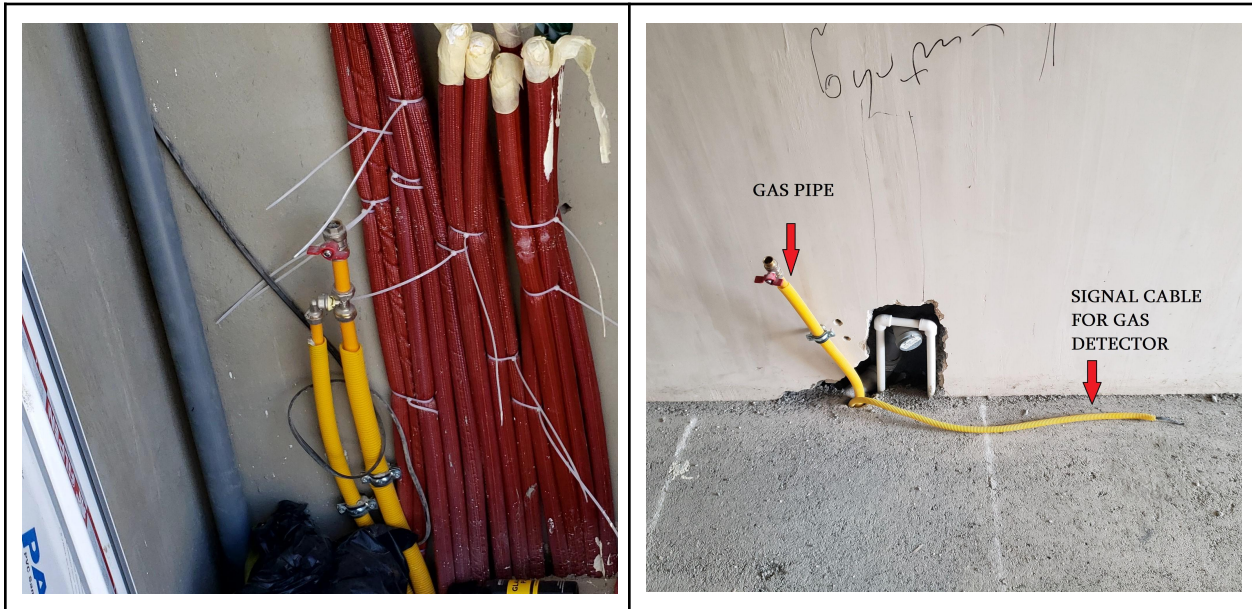
2.3 GAS

Gas leakage can not be tested as the gas was not switched on in the apartment.

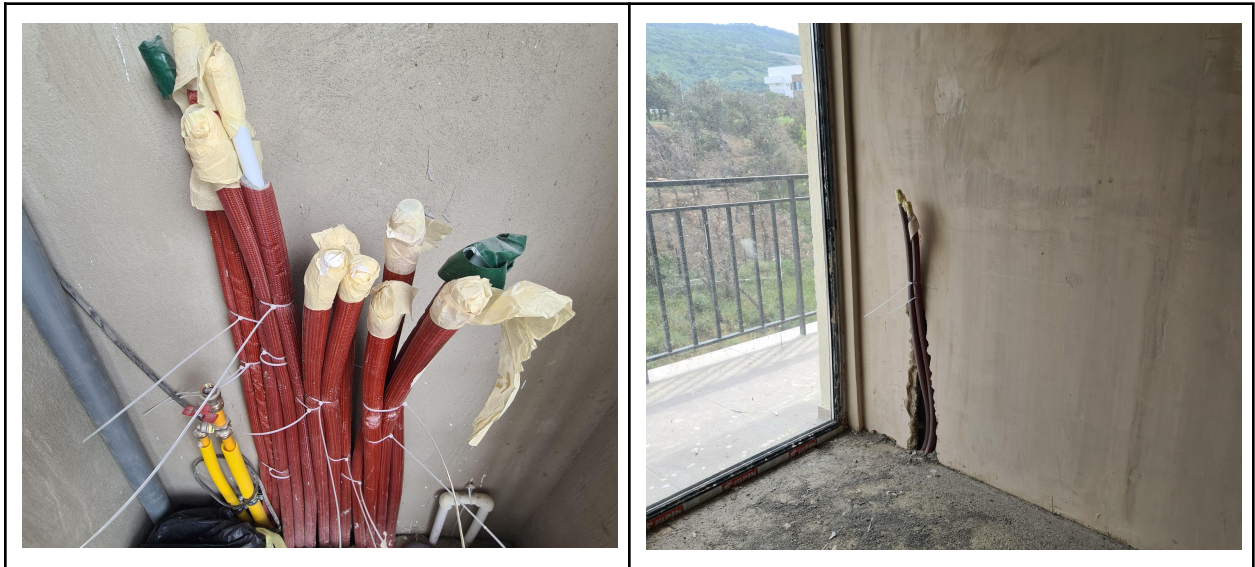
2.4 HEATING/COOLING

The pressure was not tested, as there is no gas in the apartment. The piping is in compliance with the standards.

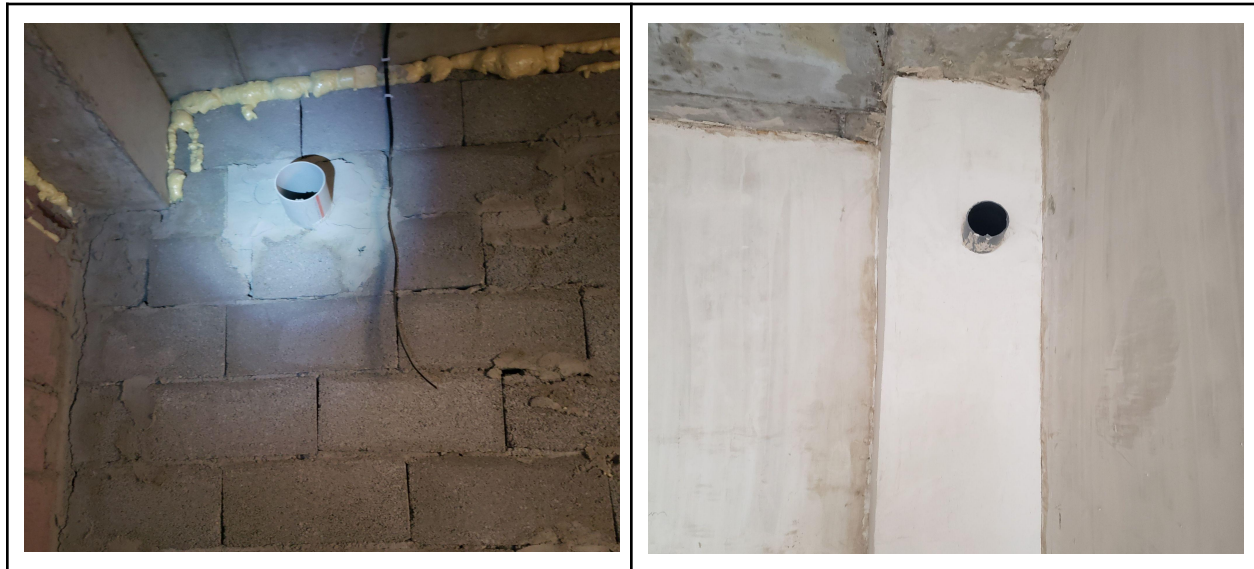
2.5 VENTILATION/AIR EXTRACTION

In this building, sewer and ventilation are in the same shafts. In this apartment there are two shafts, one in the bathroom and the other one in the kitchen area. In both areas there is a visible air extraction pipe.

No defects were detected at the time of inspection.

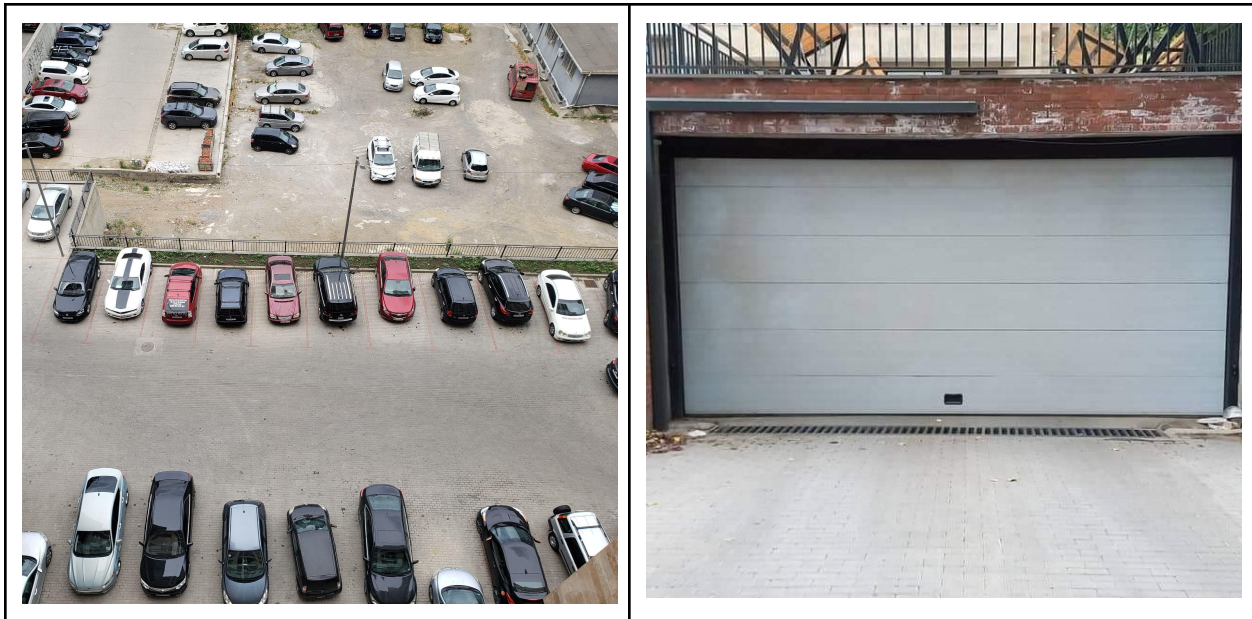
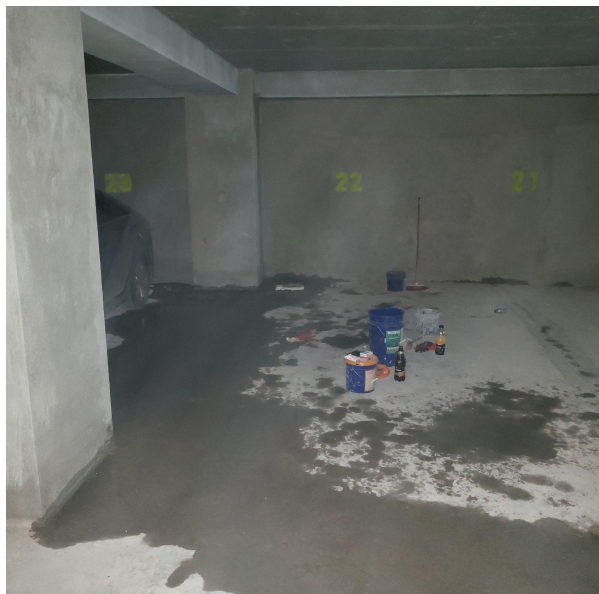
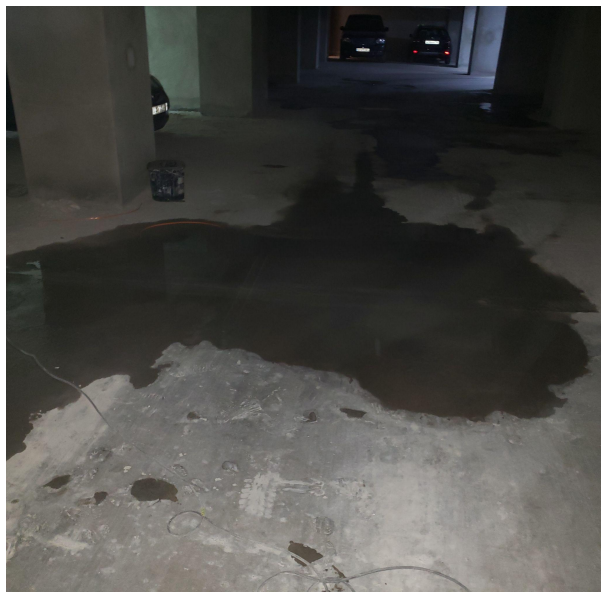
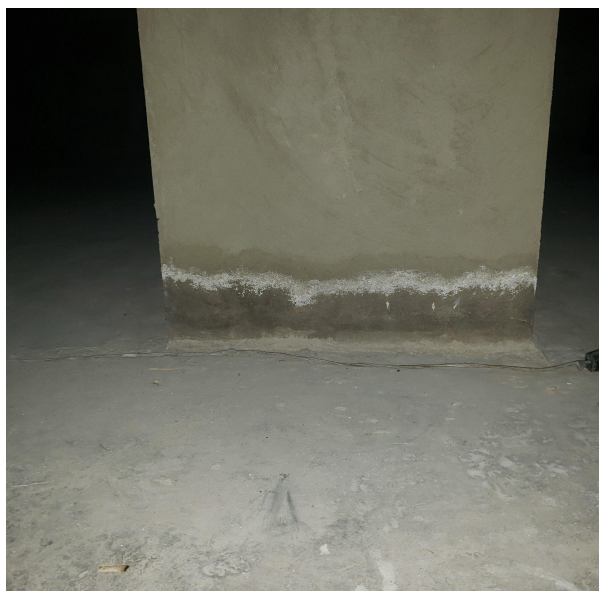
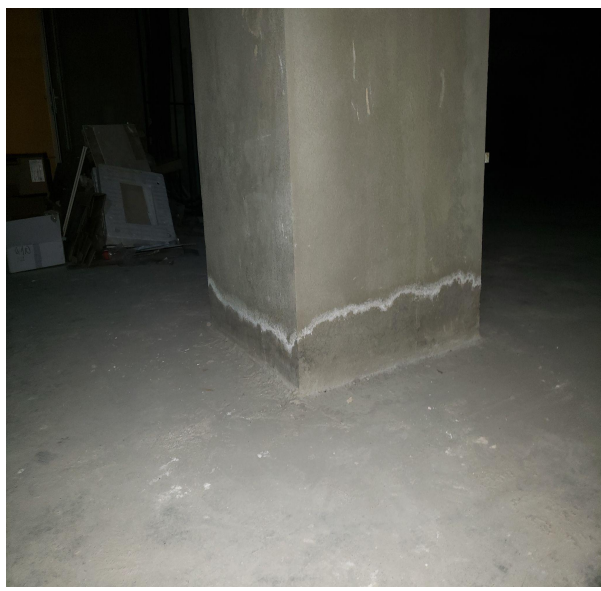
3.1 PARKING/DRIVEWAY

The main problem in the building is the standing water in the parking area, which can cause serious structural damage. Also it seems that standing water is an overall problem in this building. There is the same problem on the roof and outside areas. Water drainages, downpipes, etc., is something that was not considered before construction works started.

Parking has standing water in the parking area at least 5cm from the ground. It seems there has been more water before, as the marks of it are even higher. Standing water can cause serious structural problems.

The problem should be fixed with the help of a geologist, who will determine the cause of the water, and an engineer who can provide the solutions. As for now, the construction company has covered the holes in the walls and confirms that the problem is fixed. However, it should be inspected after a rainy day to see if the problem is actually fixed.

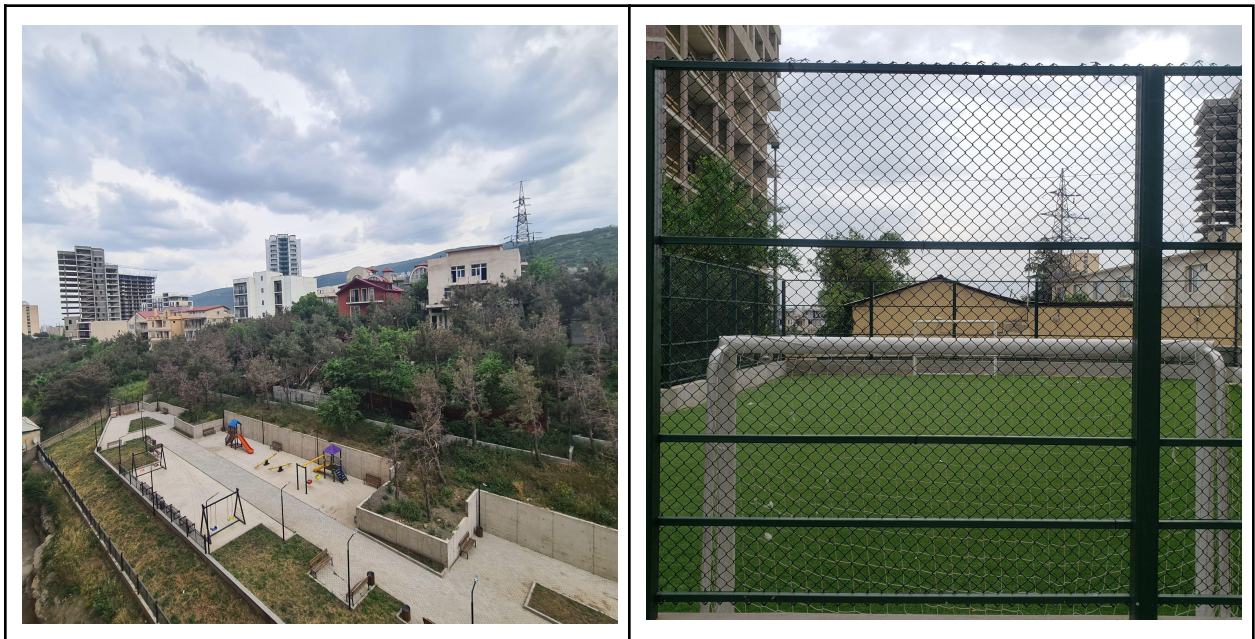
3.2 GREEN AREAS

Children's playground area does not have any safety covering on the ground.

It will need sand or rubber covering for children to not hurt themselves.

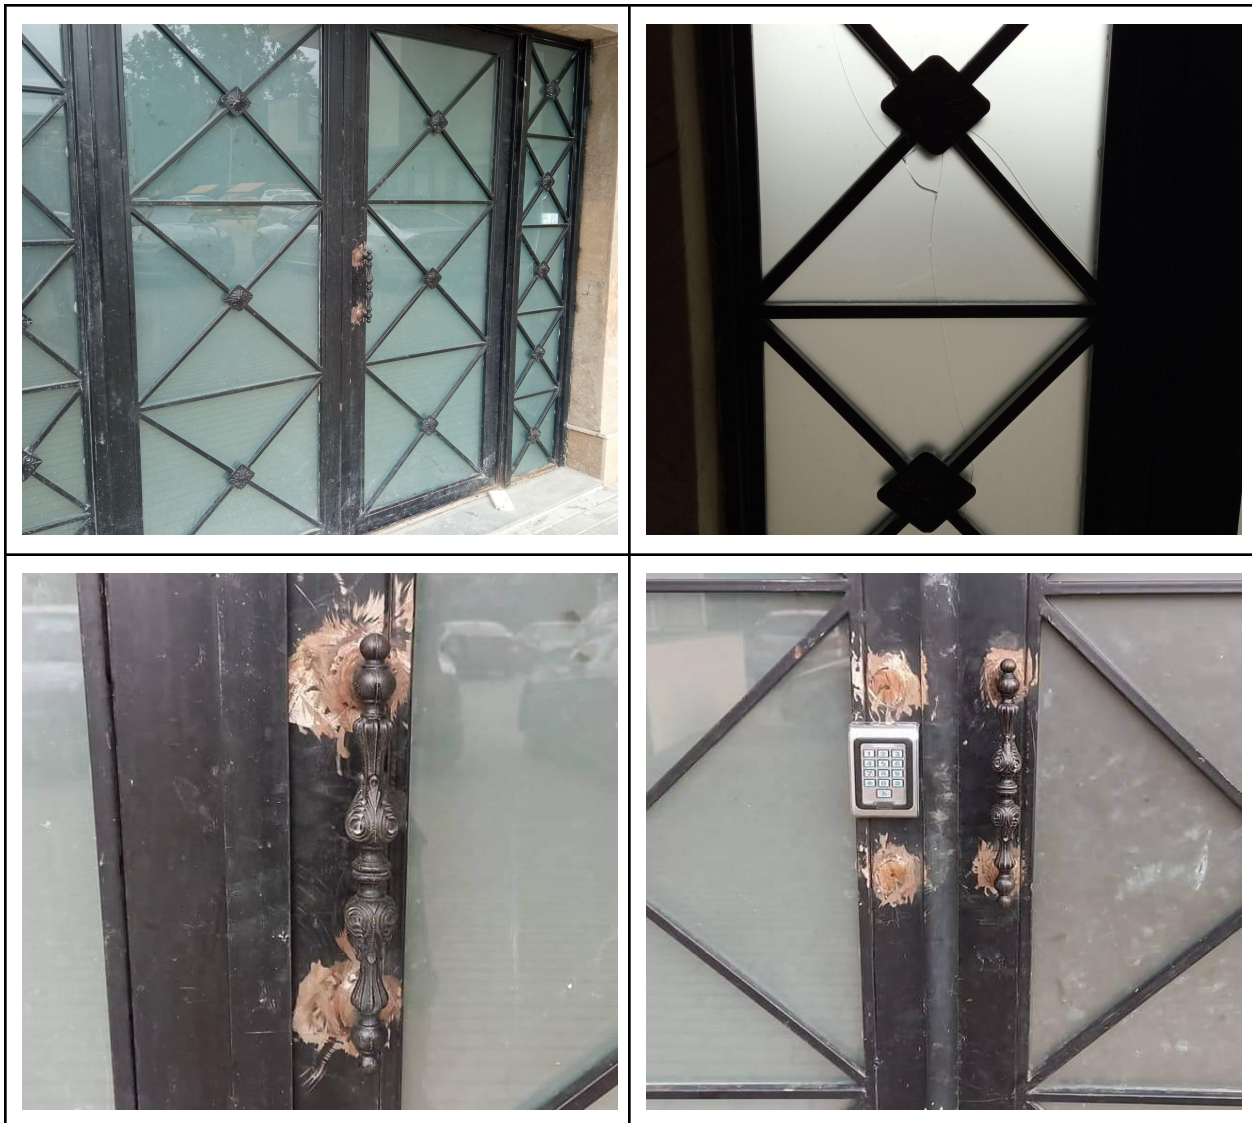
3.4 ENTRANCE DOOR

The door closes roughly. The glass on the door is broken. The handle of the door has been moved, and therefore it has lost its color.

The door needs a special mechanism that allows it to close gently. The broken glass should be replaced. The door should be plastered, smoothed and painted.

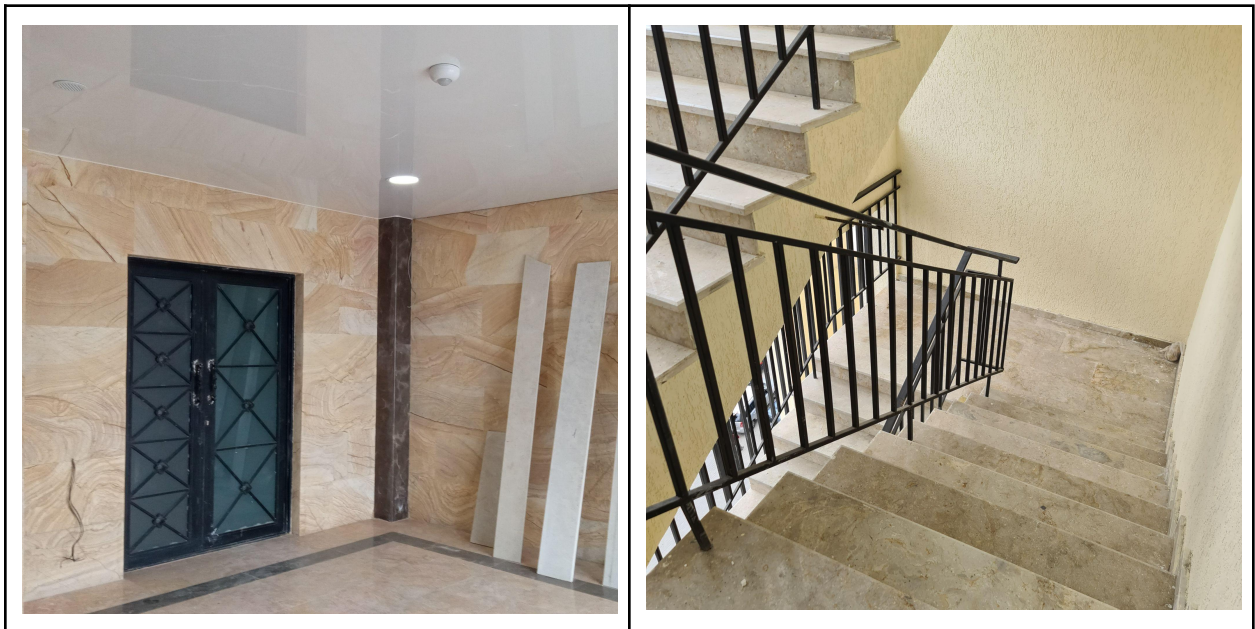
3.5 LOBBY/STAIRWAY

No defects were detected at the time of the inspection.

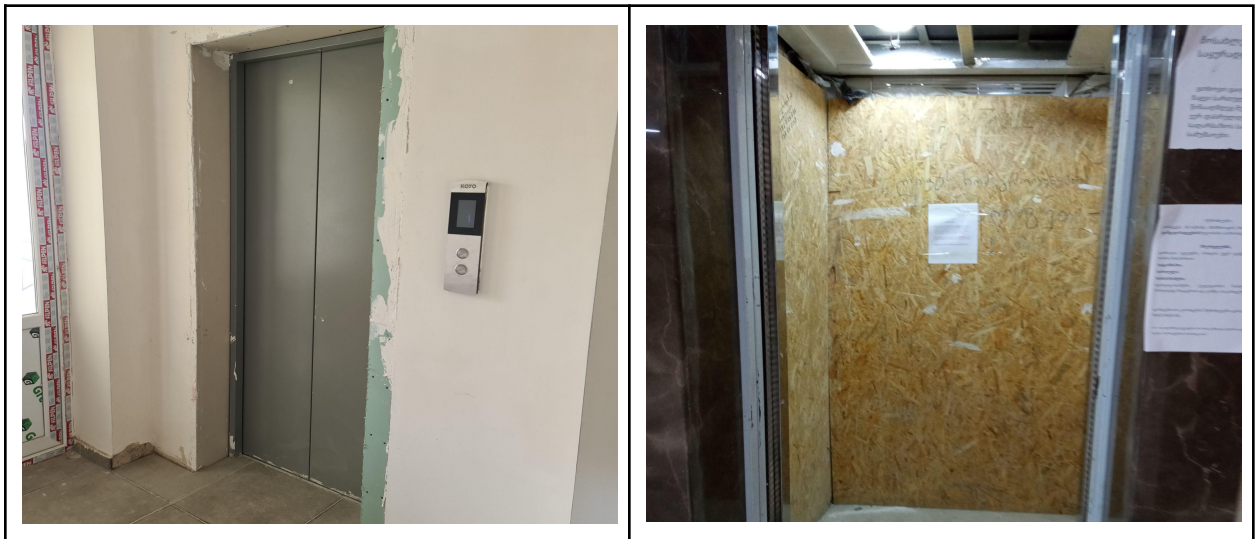
3.6 ELEVATORS

The building has 2 elevators per every stairway. Both are the same size and this size is considered as passenger elevator size. One elevator is not switched on at the moment and the other one has protection inside so the walls will not be damaged. According to the new standards, at least one elevator has to be 2m in size. This project was confirmed before the new norms were issued.

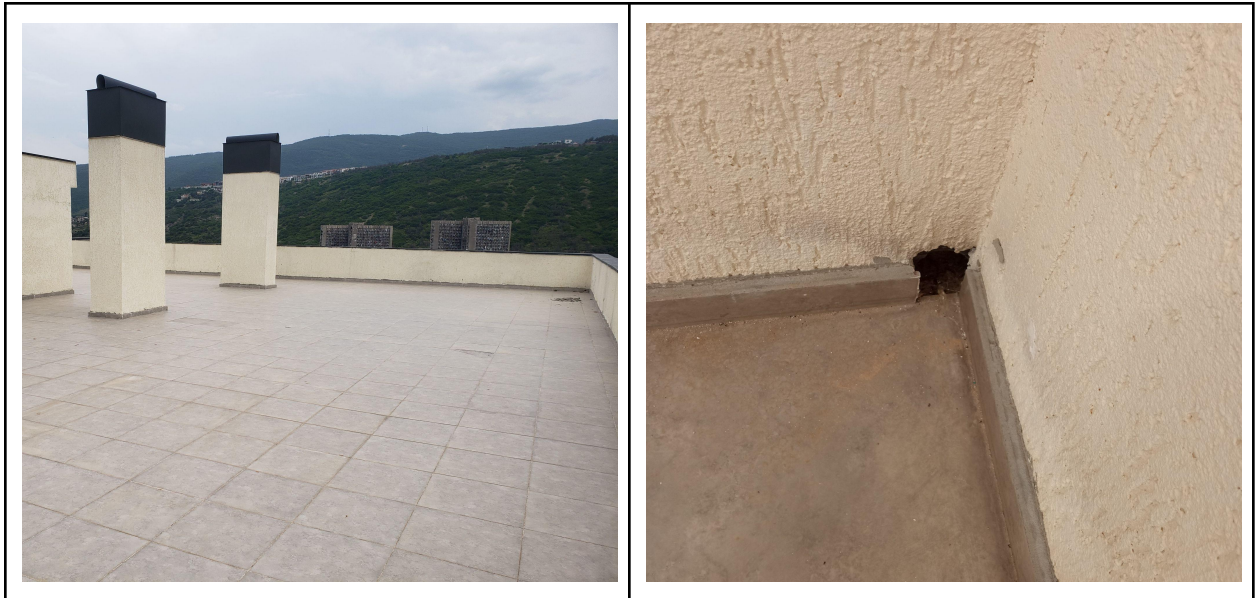
3.7 ROOF

As it seems, there was no downpipe or drainage made for the roof. From the tiles it is visible that there has been standing water on the roof. Although now there is a downpipe and a drain hole made on the roof, the surface of the roof is uneven, which makes the water still stand on the roof in many areas where it is lower. Many tiles have been damaged with small cracks and holes.

To keep standing water from gathering on the roof, there should be more traps to take away any standing water. This, however, should have been done before the tile work.

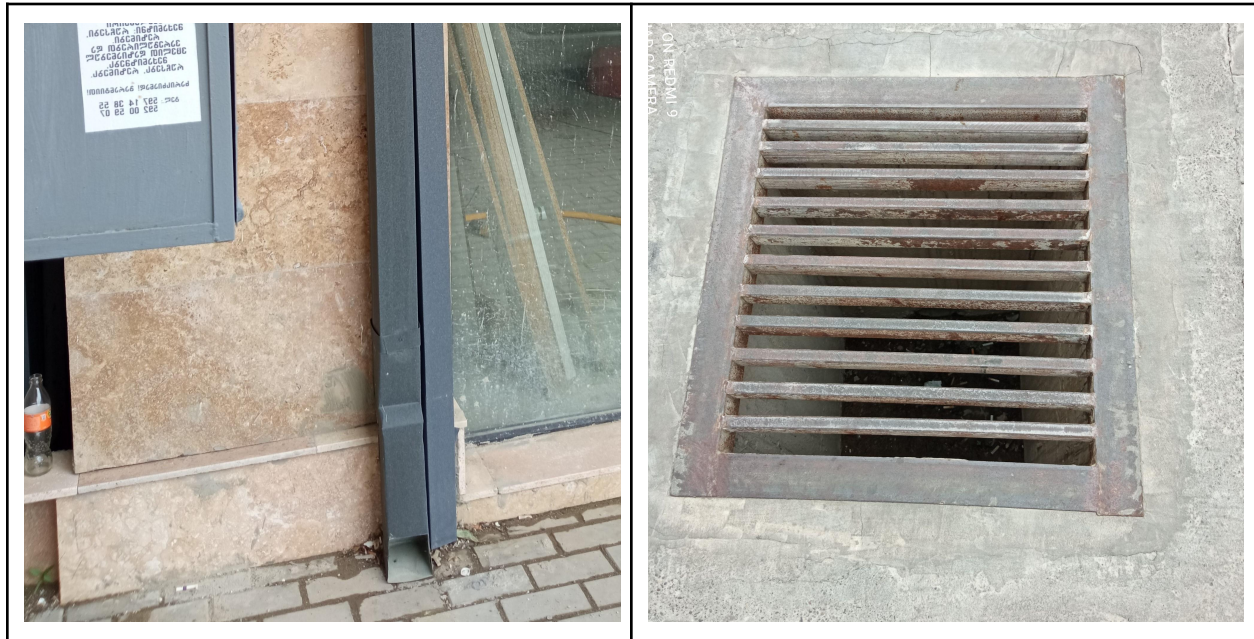
3.8 DRAINAGE/DOWNPIPES

Downpipes are not connected to the drain which means that the rain water will remain in front of the building. As the ground is uneven, there will be standing water on the ground everytime it rains.

It is recommended to connect the downpipes with the drain, so that the water will not stay on the ground.
